September 15<sup>th</sup>, 2023

TY202002.1100 (HIR)

Subject: City of Greater Sudbury – ENG21-38 - Hot In-Place Recycling (HIR), Pilot Project on Kingsway (MR 55) from 375m West of Hwy 17 Bypass to 400m East of Second Ave, Sudbury – Ontario

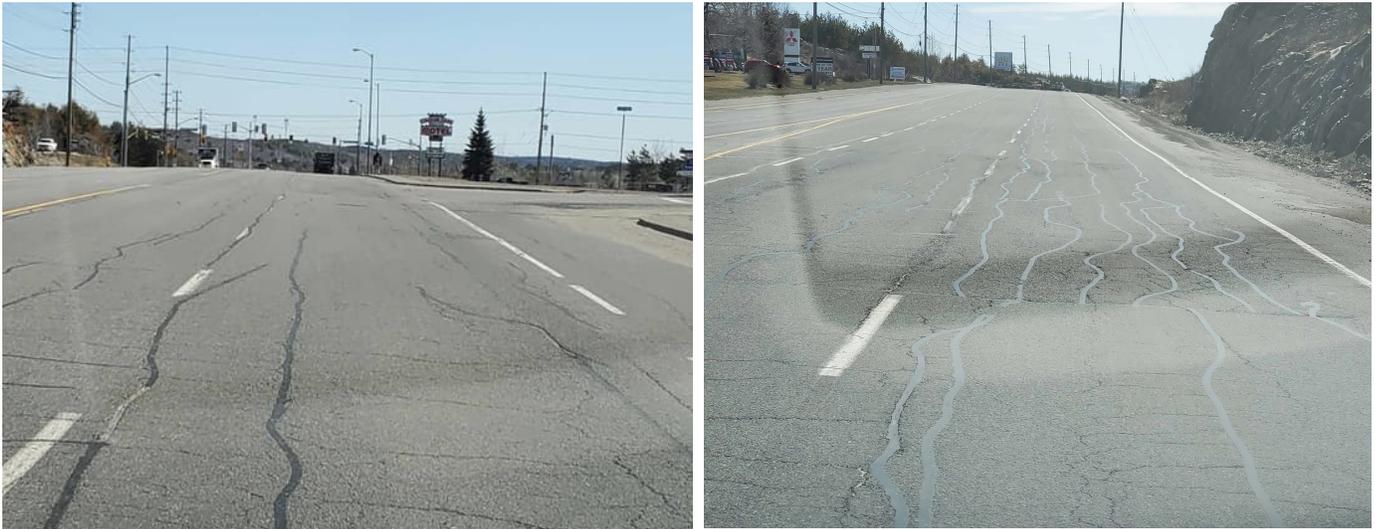
Photo 1: Kingsway Condition in 2020 Prior to HIR

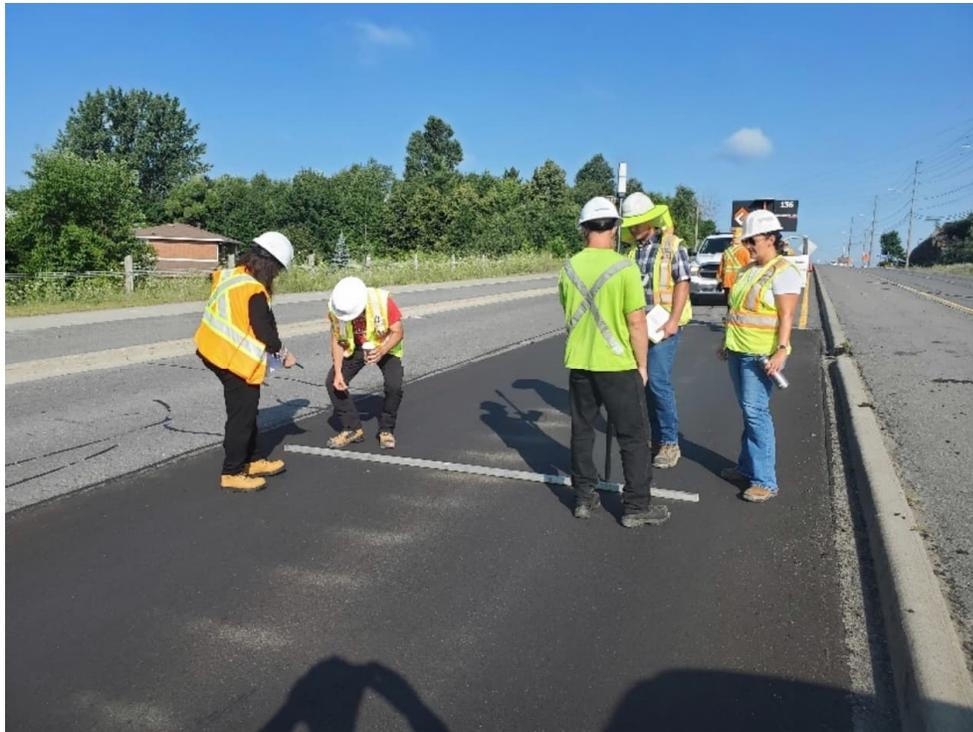
- 57.4% of measurements were either equal to or less than 3 mm;
- 18% between 3 and 4 mm;
- 15.4% were between 4 and 5 mm;
- 6.2% were between 5 and 6 mm, and
- 3% were greater than 6 mm.

Photo 2: Surface Smoothness Testing with a 3 m Long Straight Edge

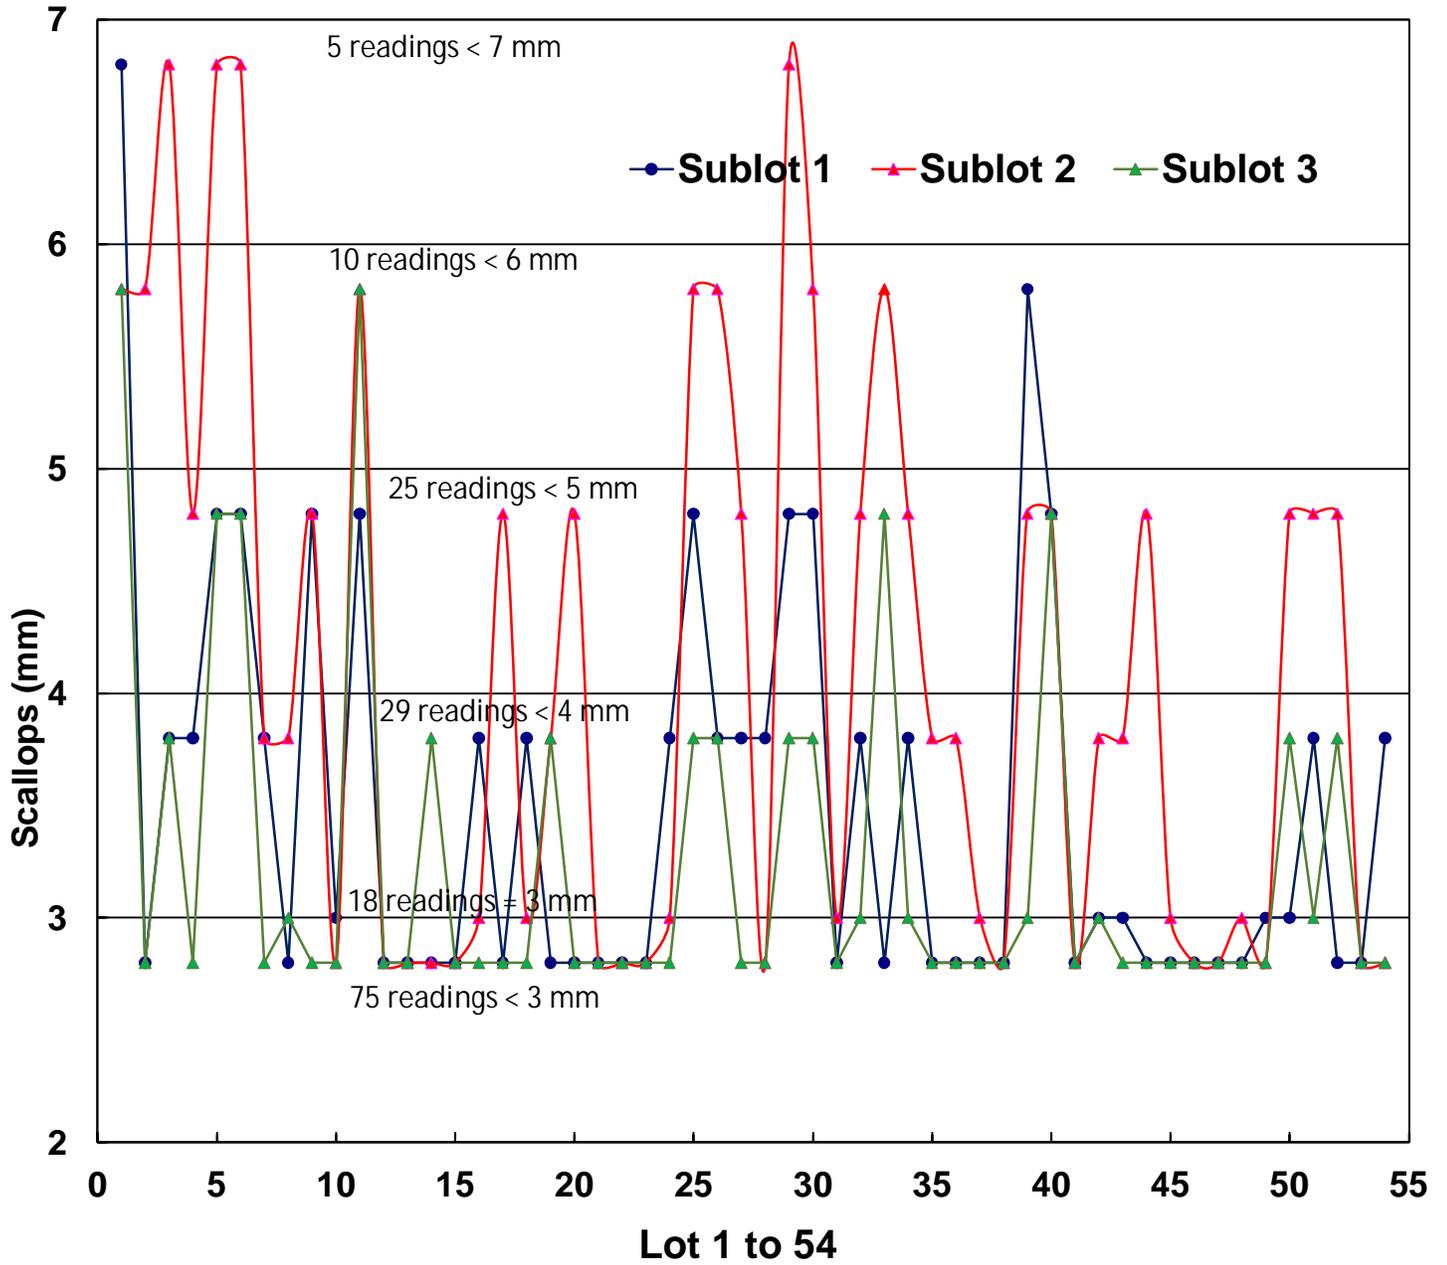
A total 54 lots with 3 sublots each (~ 162 measurements) were taken with a deviation from the straight edge to the ground as follows:

Figure 1: Smoothness Testing.

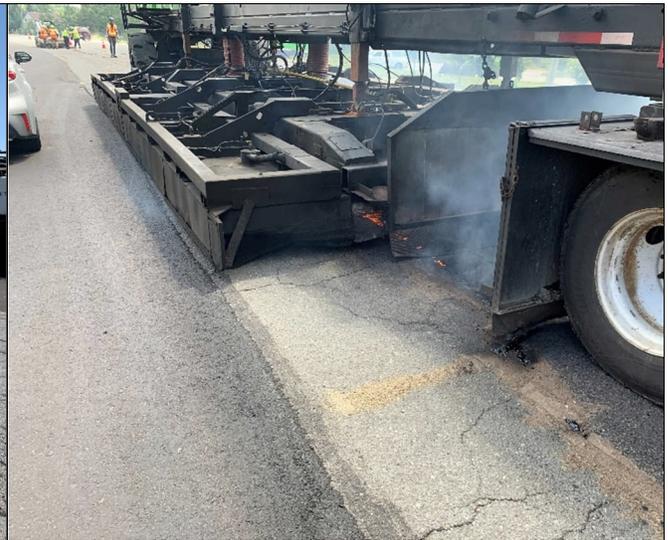
Photo 2: Open flame was observed in contact with the road surface.

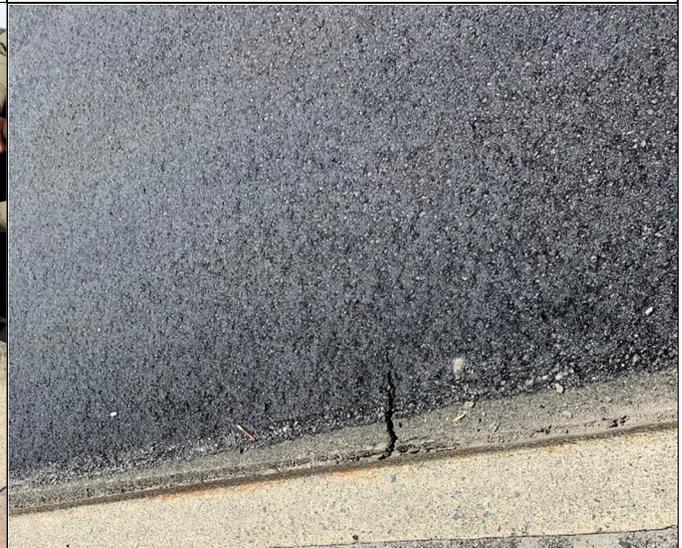
Photo 8: Perpendicular cracks along the road.

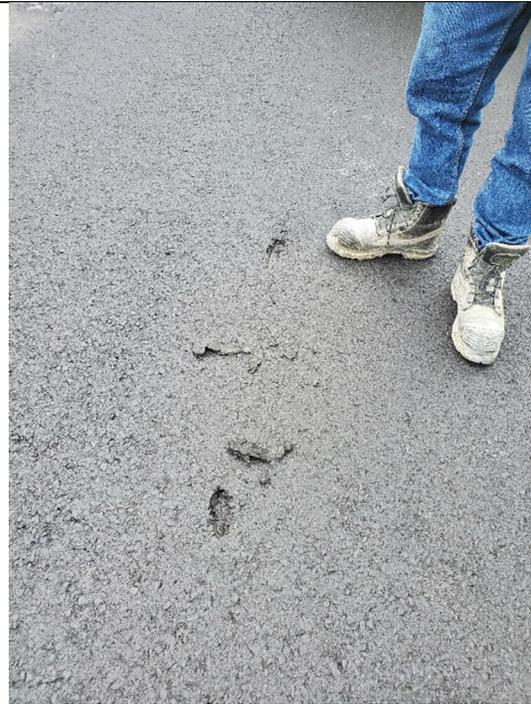
Photo 2: Voids/pieces of loose rubber after being removed from the surface of the asphalt.

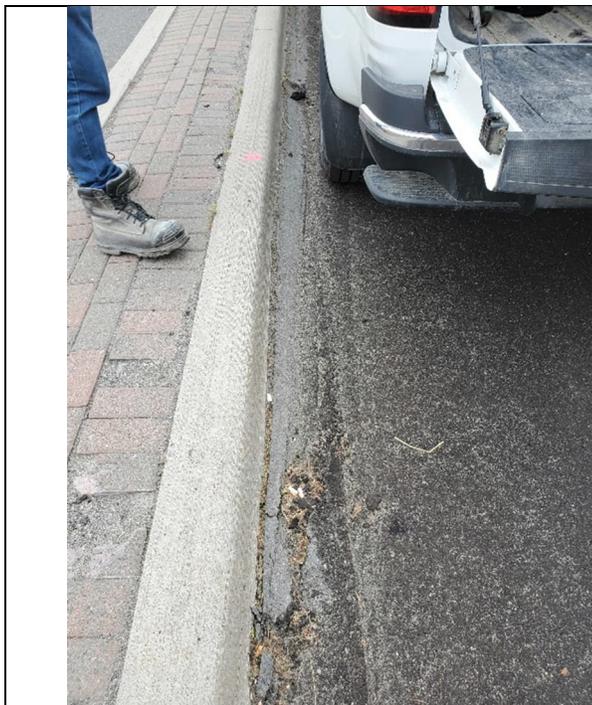
Photo 5: Cracks/loose asphalt observed in the section along the centre island.

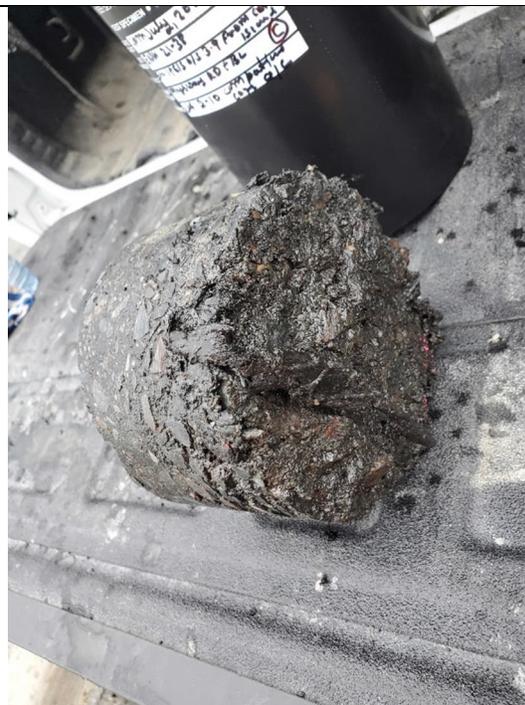
Photo 6: Core 11C with uneven bottom edge.

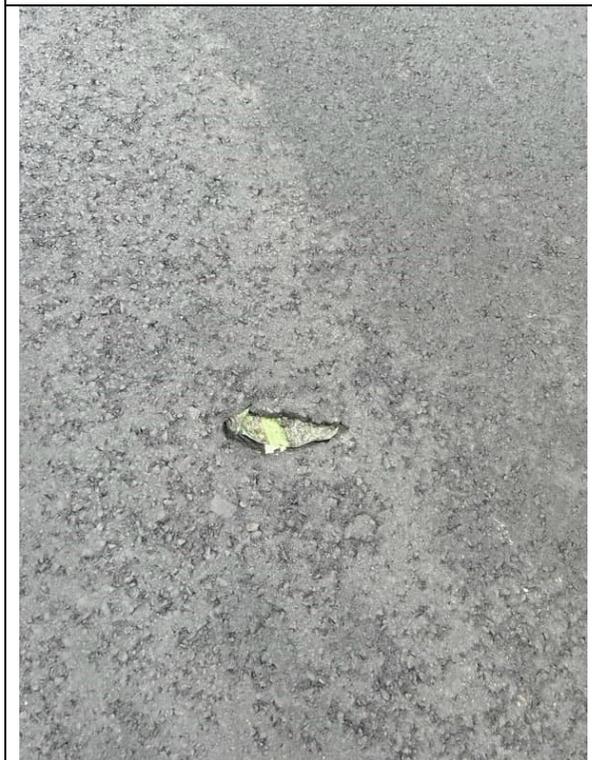
Photo 7: Plastic bottle observed in the surficial asphalt near STA 2+000.

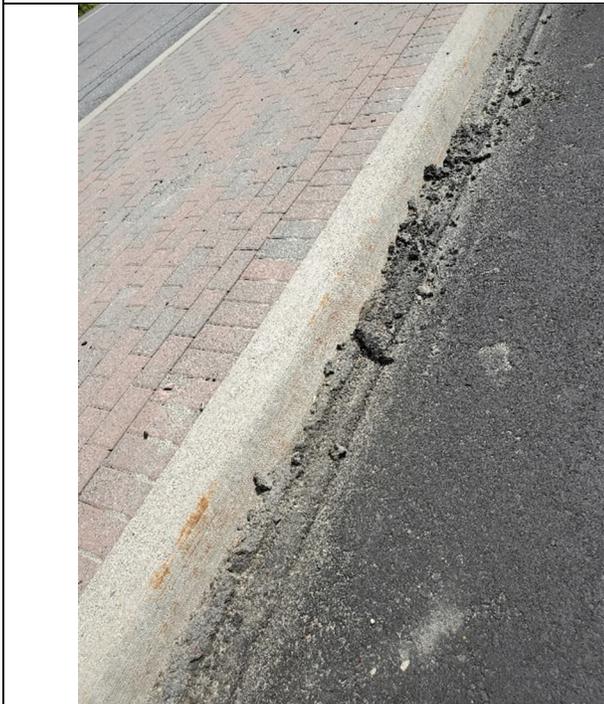
Photo 3: Broken/loose older existing asphalt in thin strip along the eastbound passing lane centre island.

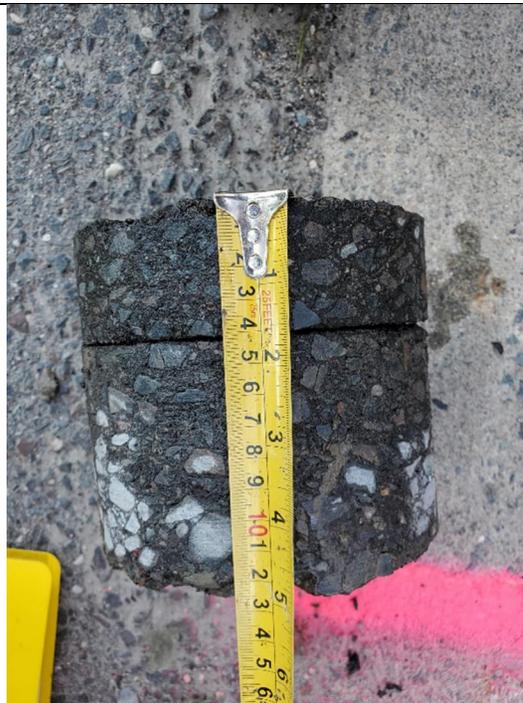
Photo 6: Additional Set 1, Core A1B, broken into 2 pieces.

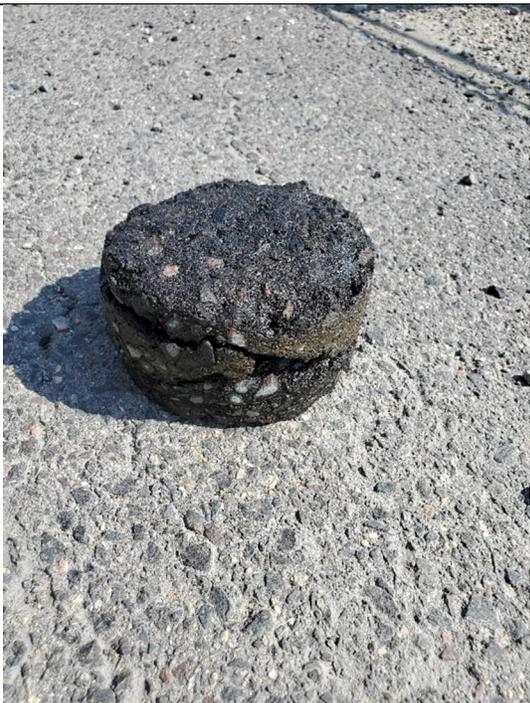
Photo 7: Additional Set 2, Core A2A, broken into 3 pieces.

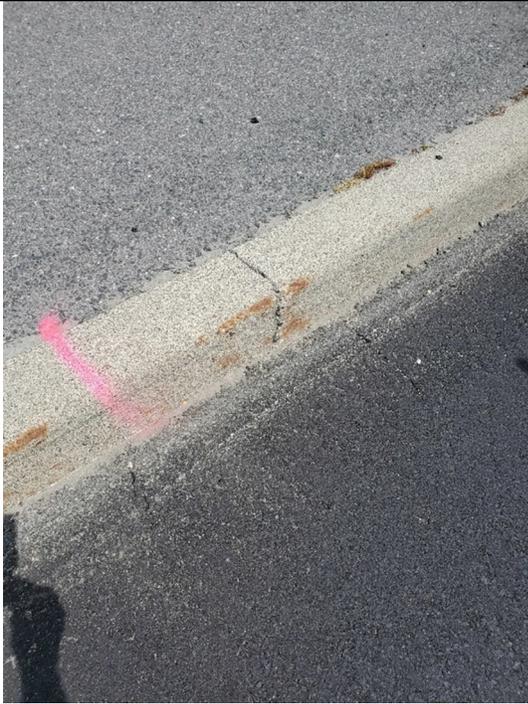
Photo 5: Cracks observed in the asphalt along the centre island.

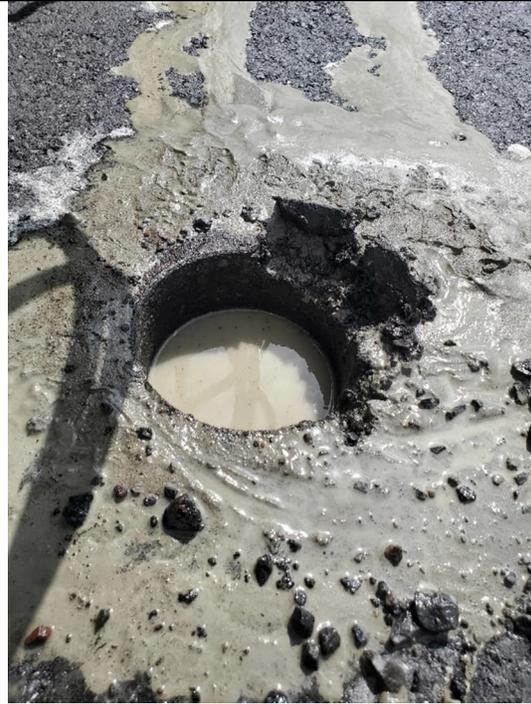
Photo 6: Core 5A hole with lifted/fractured edges.

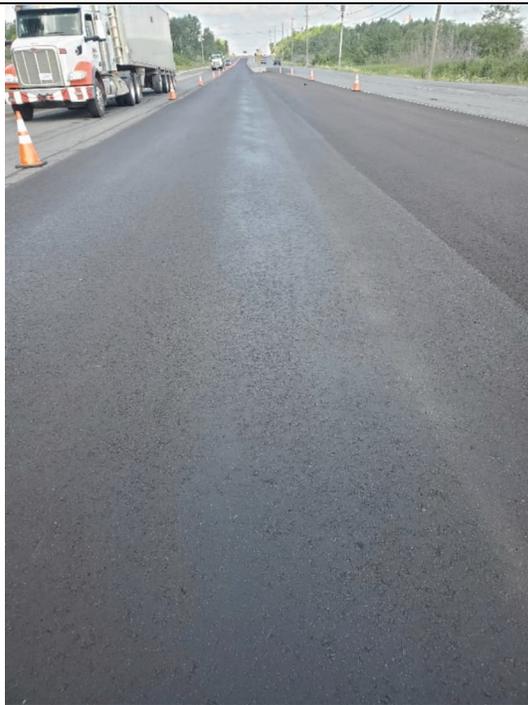
- Segregation was noted - slight to medium predominately at mid-lane with a density range from 30 to 50%. This might be due the pavement not sufficiently heated.
- Fat Spots (multiple small) were observed in some locations due to faulty construction practices or oil spill.
- Flushing /bleeding was observed through 10 to 15% of the assessment area. This might be due to improper mixing or high rejuvenating content.
- Transverse cracking - slight/few cracking were observed in isolated areas near the concrete curb of the island that ranged from 170 mm to 370 mm in length.

Photo 5: Flushing observed in Section 10.

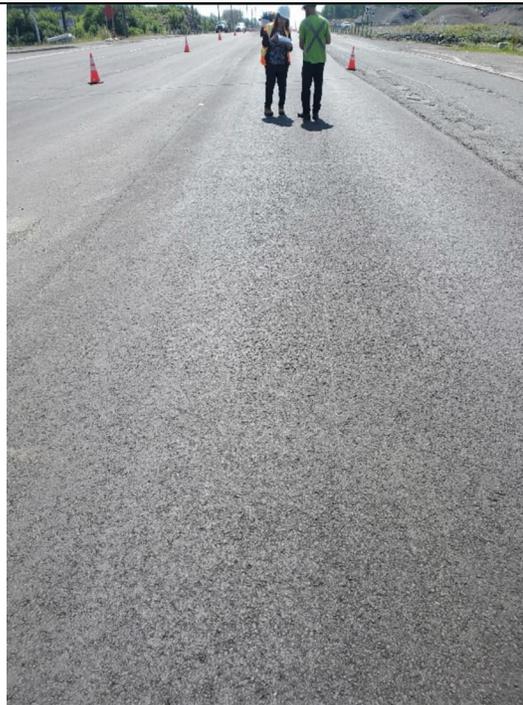
Photo 6: Moderate to severe segregation in Section 14.

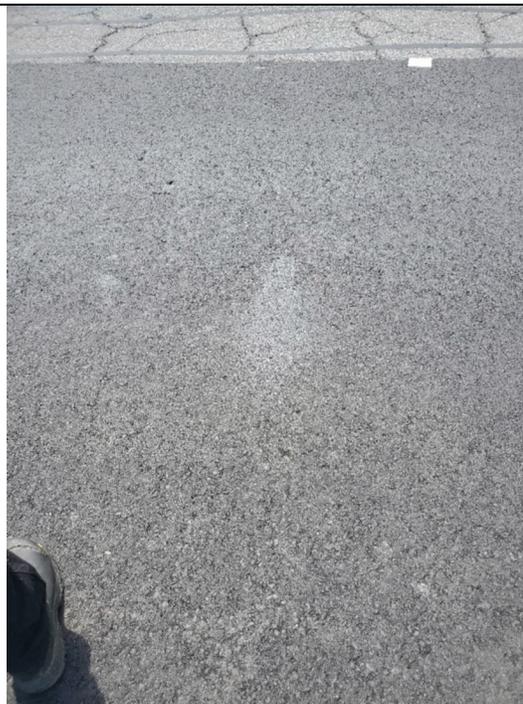
Photo 8: Fat spot observed at Survey Point 93.

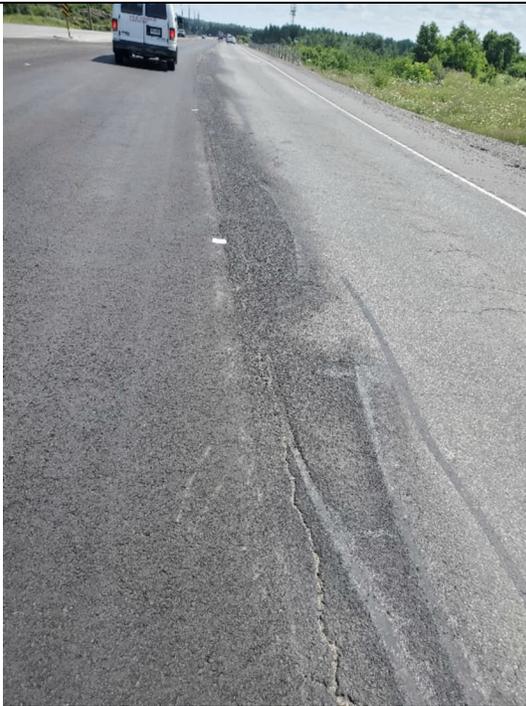
Photo 9: Burned asphalt at Survey Points 100 and 101.

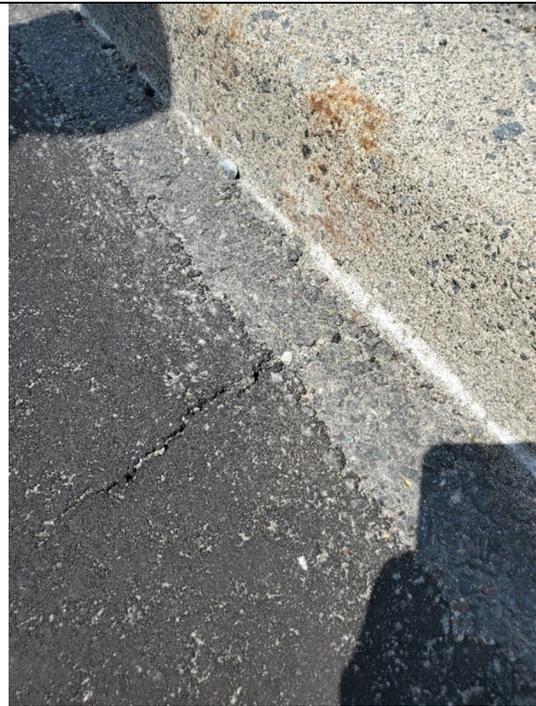
Photo 10: Crack observed at Survey Point 117 and 118.

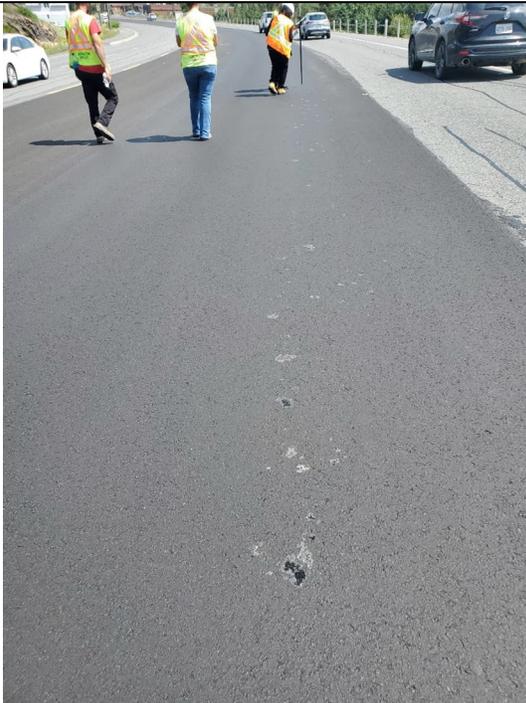
Photo 11: Fat spots observed at Survey Points 124 and 125.

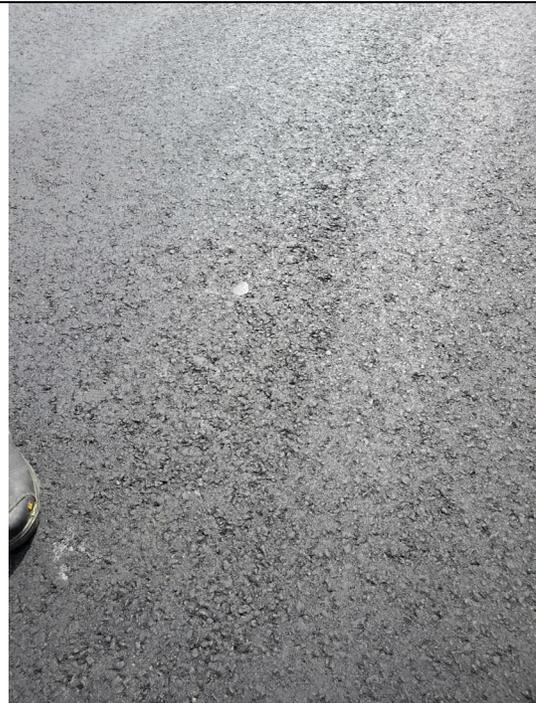
Photo 12: Severe segregation at Survey Point 169.

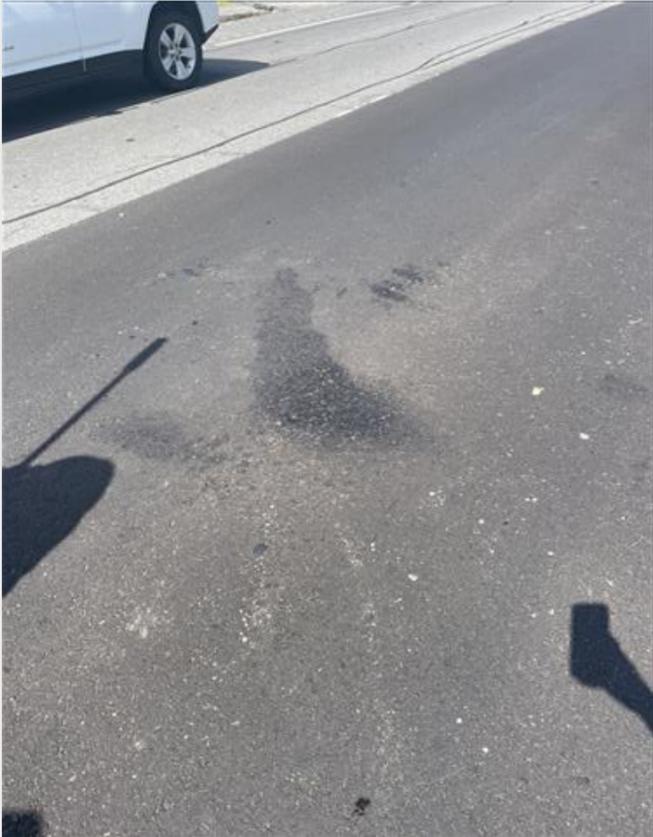
<b>PHOTOGRAPH</b>	<b>5</b>
		<b>STA 0+500 to STA 0+750</b>	
		Moderate Flushing/Bleeding

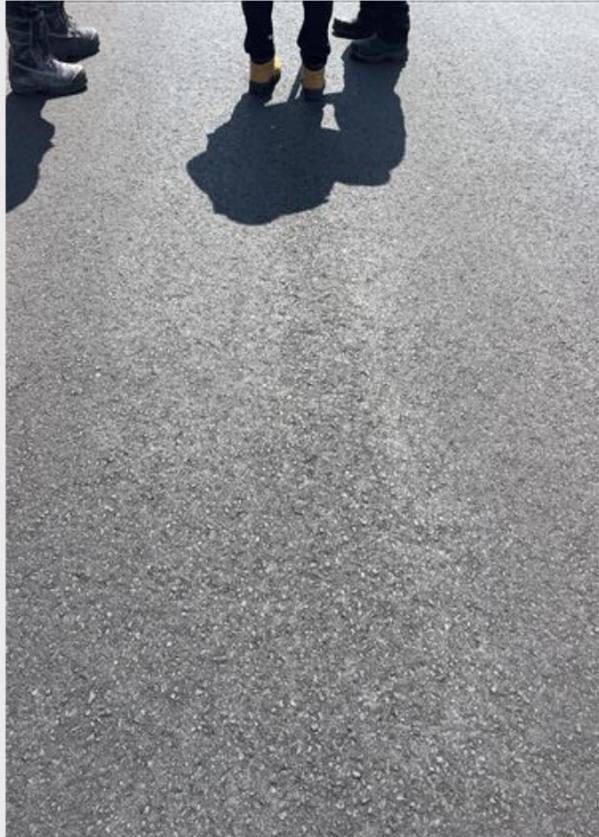
<b>PHOTOGRAPH</b>	<b>6</b>
		<b>STA 0+500 to STA 0+750</b>	
		Fat Spot	
		Medium - Segregation
