## TOWN OF PEACE RIVER Information Briefing Note

<b>To:</b>	Mayor and Council	<b>Date:</b>	July 11 <sup>th</sup> , 2022
<b>Presenter:</b>	Jim McCuaig, P.Eng.	<b>Prepared By:</b>	Jim McCuaig, P. Eng.
<b>Topic:</b>	101st Street Storm Sewer Repairs and Slide Mitigation	<b>File No.:</b>	38/150
<b>Attachments:</b>

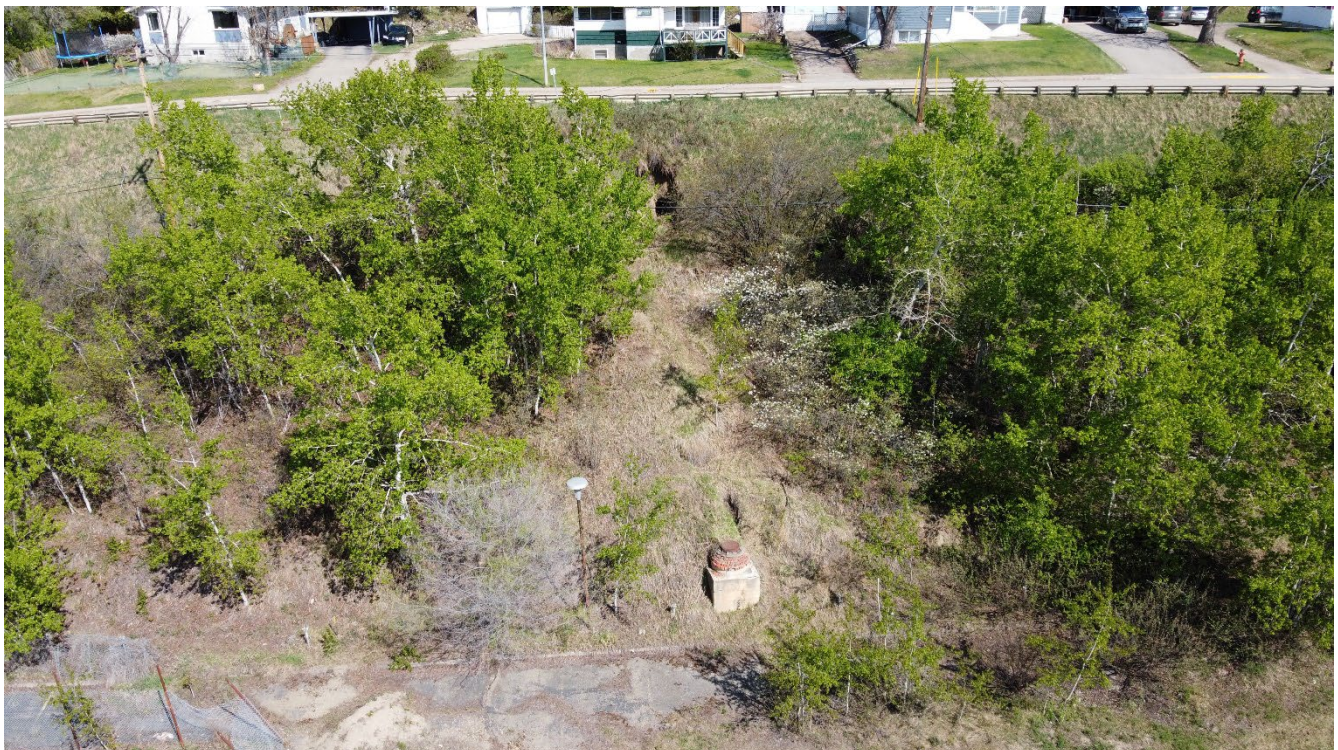
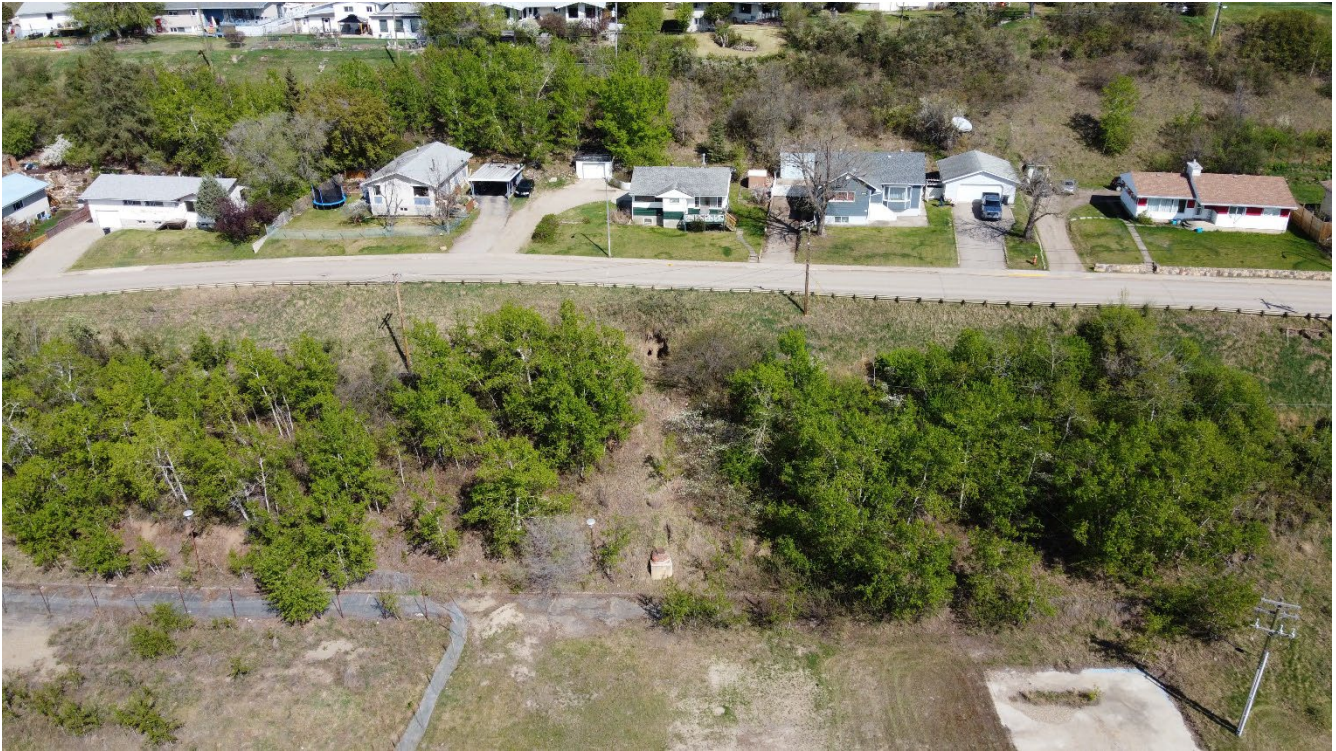
The stormwater is now saturating the hill between 101<sup>st</sup> Street and 99<sup>th</sup> Street and has caused the hill to slump as shown below:

*"Inspection of the storm drain indicated significant signs of deterioration, including rusting, pitting and corrosion of the drain about 3 m below the top of slope. The failure of the storm drain resulted in erosion of the soil surrounding the pipe, causing a large visible void. The erosion appeared to continue downslope below the ground surface along the length of the pipe. The extent of the erosion and voids below the pipe is unknown due to limited visibility."*

- Remove existing unsuitable material;
- Repair/replace the failed stormwater pipe and line portions of the pipe that have not yet failed but are beyond their service life;
- Replace material with low to medium plastic clays and crushed gravel to stabilize the slope; and
- Provide soil erosion measures to control surface groundwater.

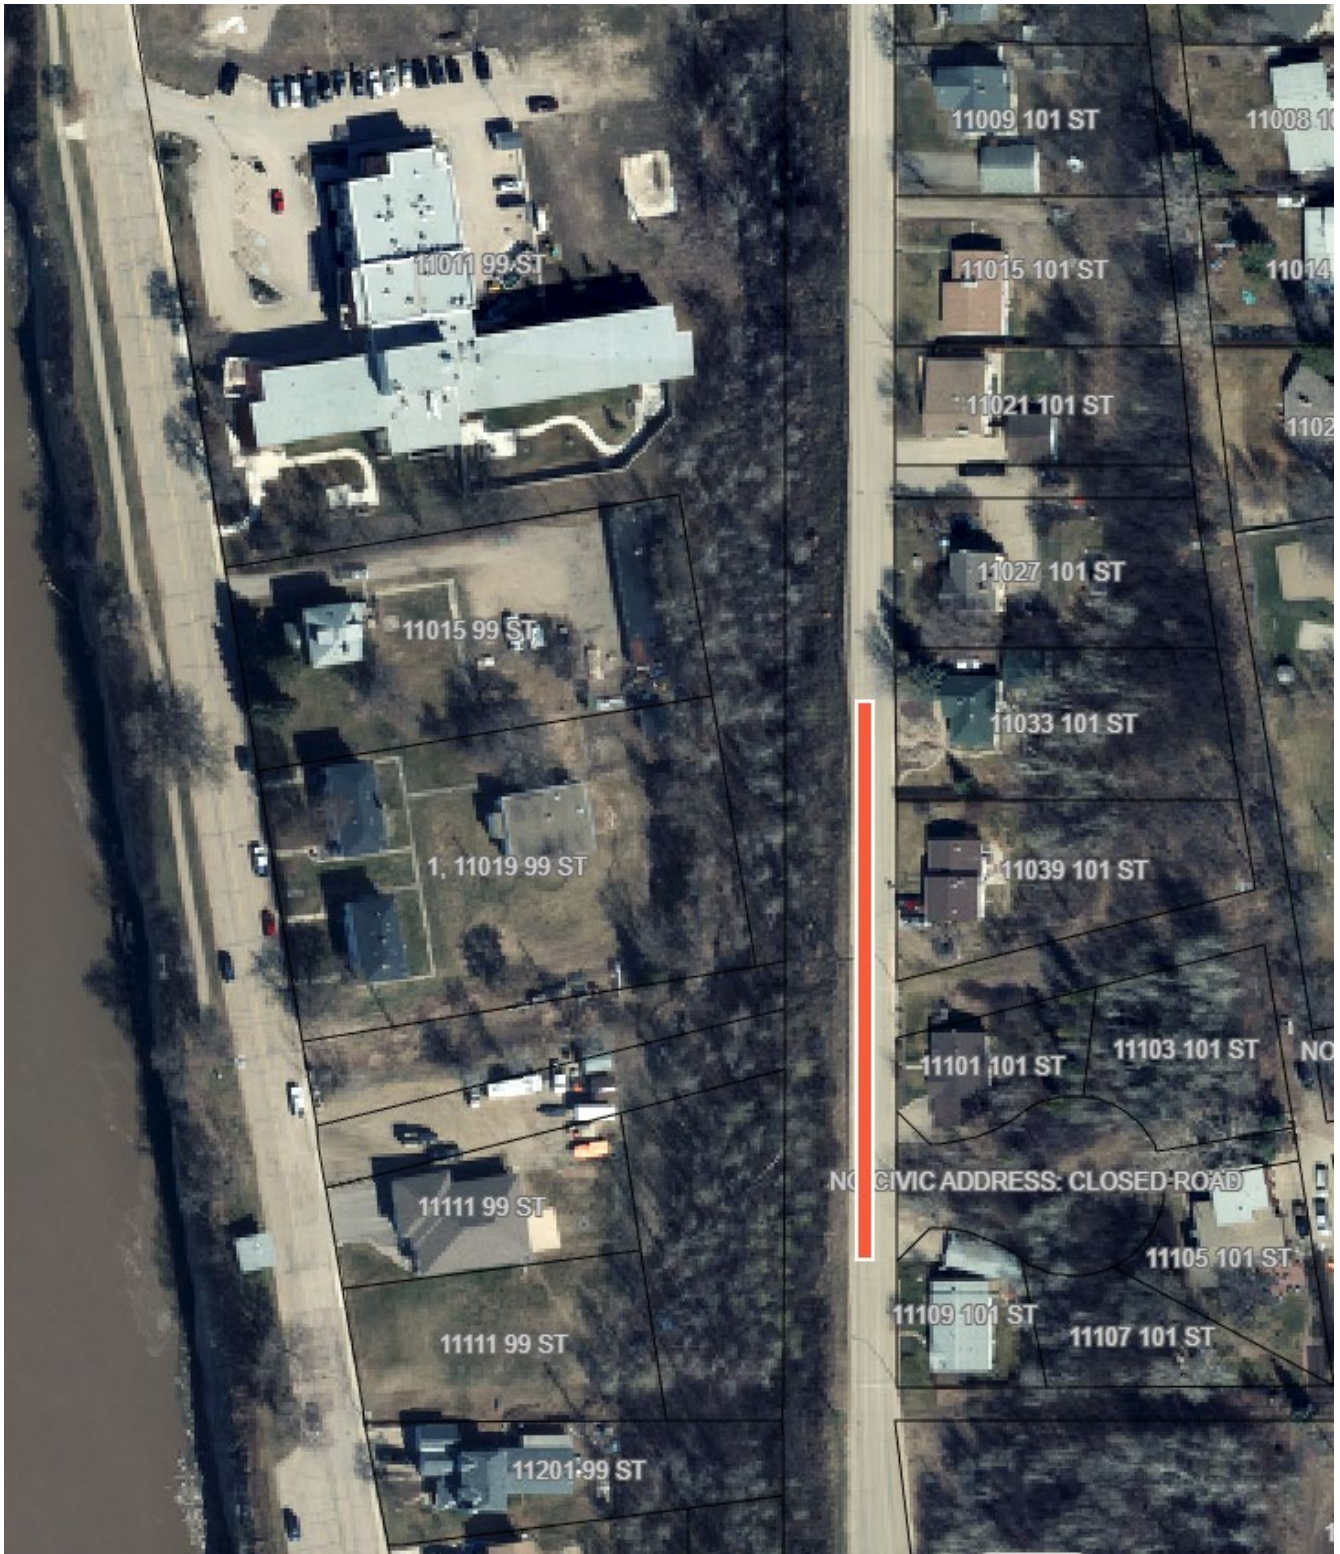
pavement to the south was noted to display tension cracking along with separation between the road structure and the gutter. Both of these signs are indicative of slope movement. Last Friday, we met with Beirsto Engineering and Parkland Geo to discuss these findings and determine immediate actions and longer-term solutions. The subject area is in red below.

- Restricting a portion 101<sup>st</sup> street to one lane traffic;
- Provide sealant along the separation between the gutter and the pavement structure; and
- Analyzing the updated geotechnical data to complete a desktop analysis.

- Evaluate options for Council to consider which may include a pile wall structure or a MSE wall structure in order to stabilize the slope and 101<sup>st</sup> Street; and
- Pursue grant funding with the Province to assist with mitigation options.

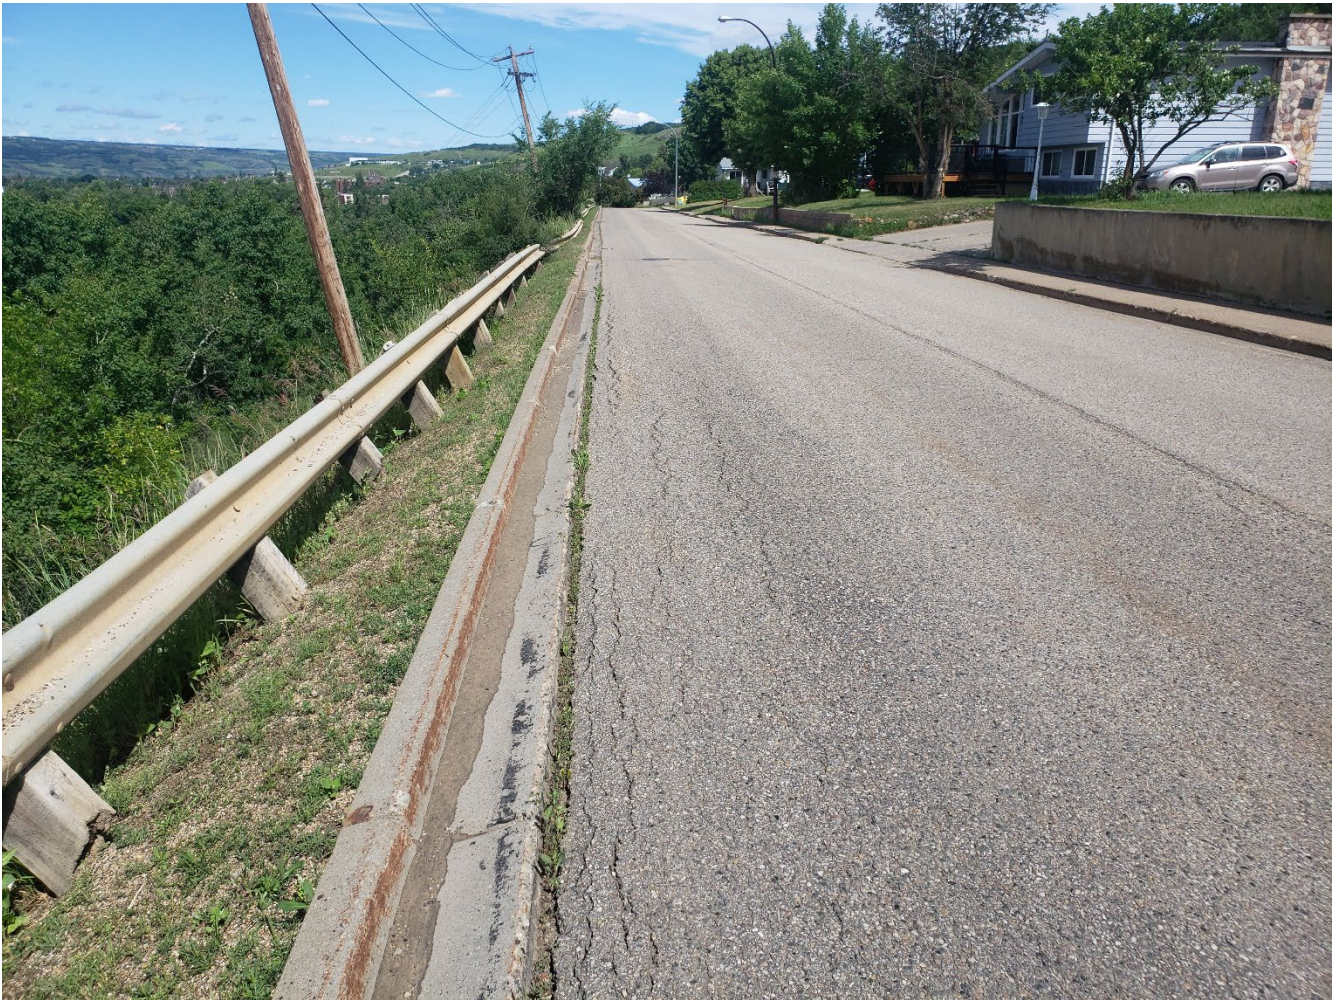
The curb and gutter can be seen in this photo as pulling away from the road structure. Also note the tension cracking in the road surface.
