September 15<sup>th</sup>, 2023

TY202002.1100 (HIR)

Subject: City of Greater Sudbury – ENG21-38 - Hot In-Place Recycling (HIR), Pilot Project on Kingsway (MR 55) from 375m West of Hwy 17 Bypass to 400m East of Second Ave, Sudbury – Ontario

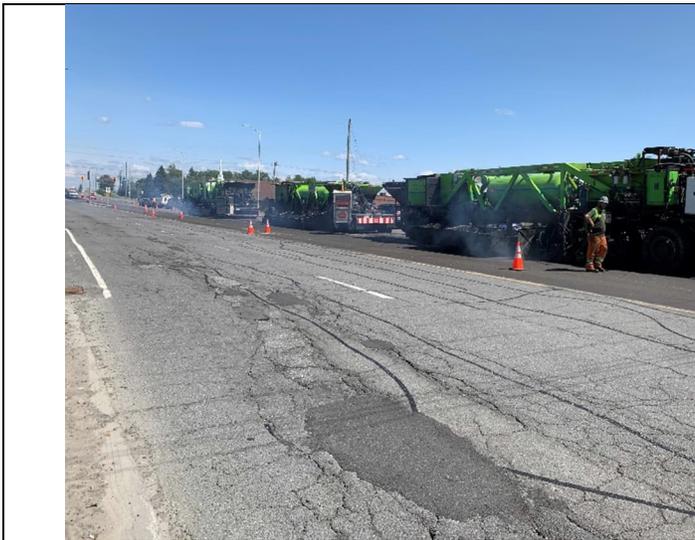
Photo 1: RSR preheating the road surface along the Kingsway.

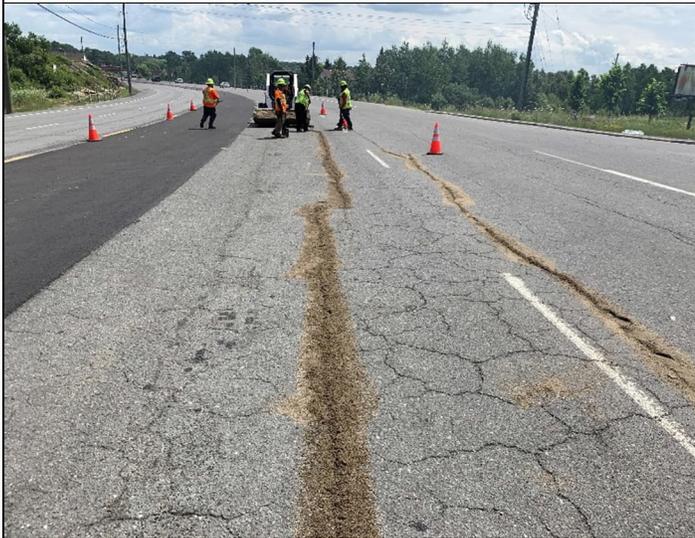
Photo 3: Placing sand over the crack sealant to avoid flare-ups during heating.

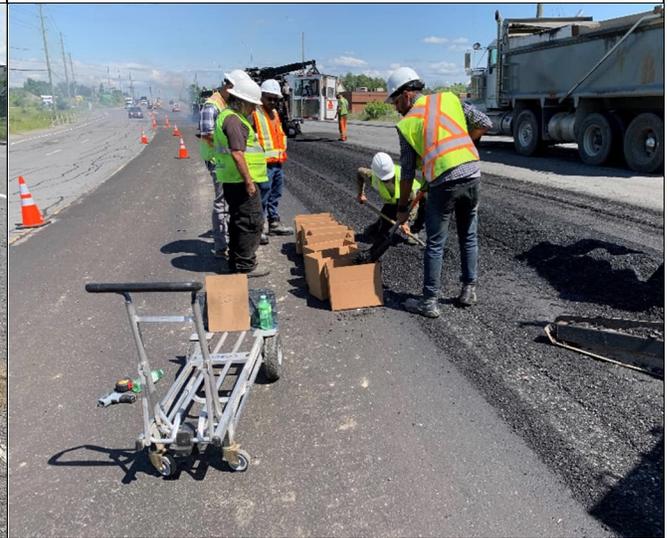
Photo 4: RSR Quality Control collecting samples from the asphalt.

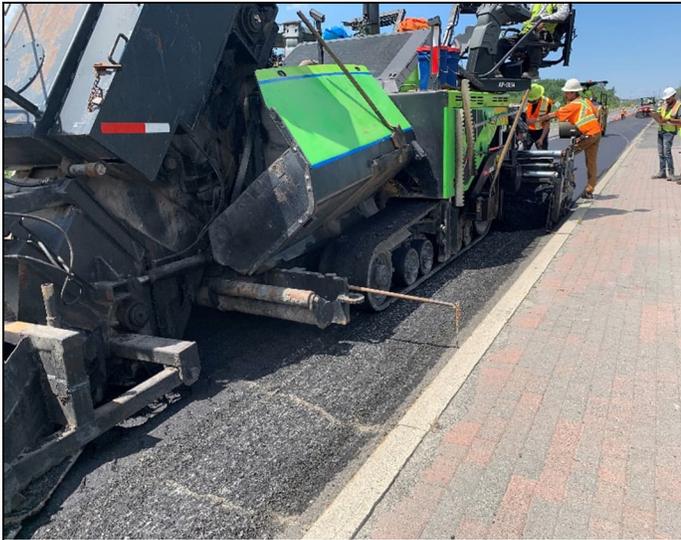
Photo 5: Placing hot-in-place recycled asphalt.

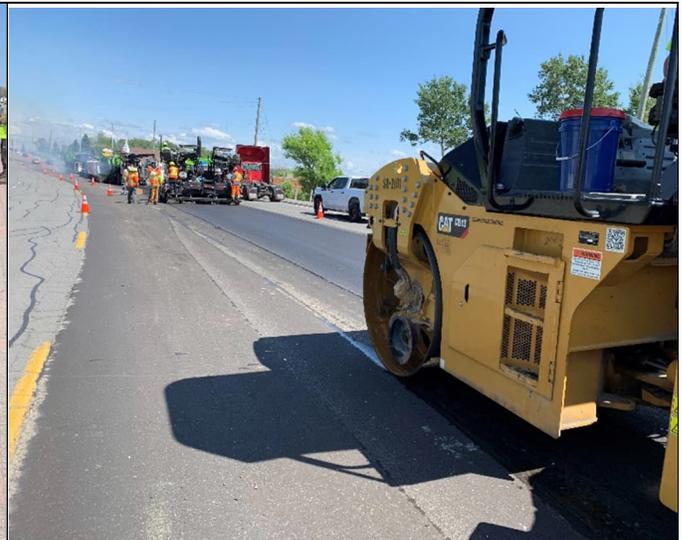
Photo 6: compacting the asphalt lift with a smooth-drum roller (12 T).

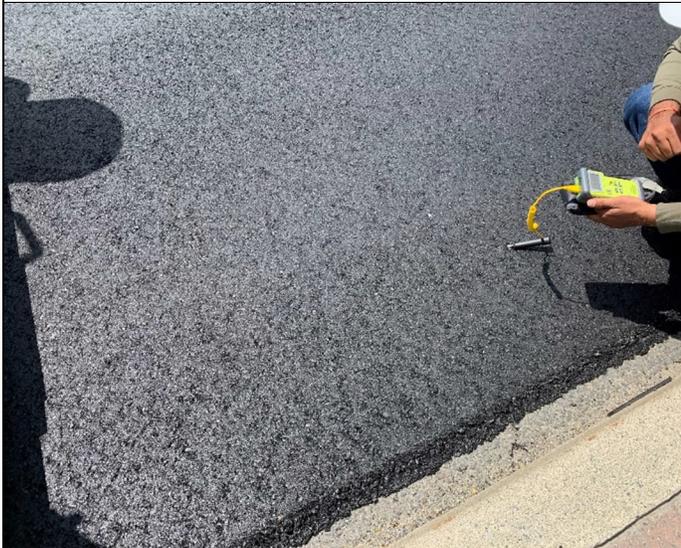
Photo 7: Measuring the asphalt temperature behind the spreader screed.

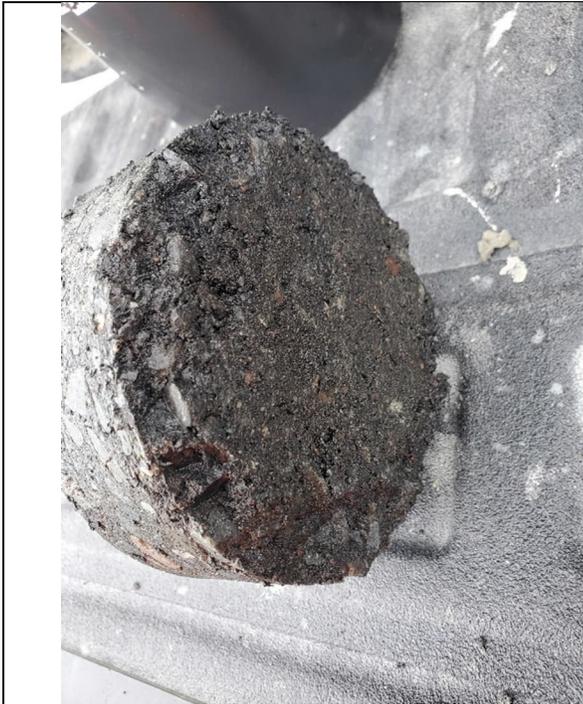
Photo 1: Bottom of Core 9B, showing voids around edges.

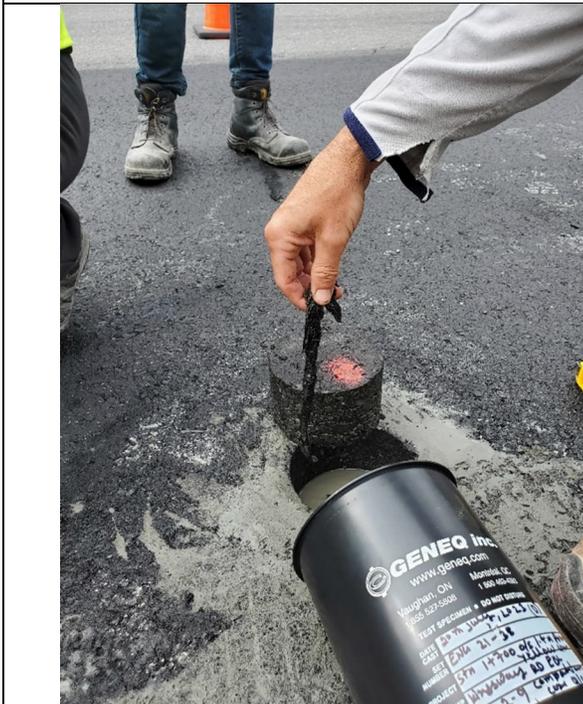
- Core 10D and 10E had chunks of rubber stuck to the outside of the sample. As shown in Photos 3 and 4.
- Section of loose/cracked asphalt observed next to the centre island around STA1+615. As shown in Photo 5.

Photo 3: Strand of rubber that was stuck to Core 10D upon removal from the ground.

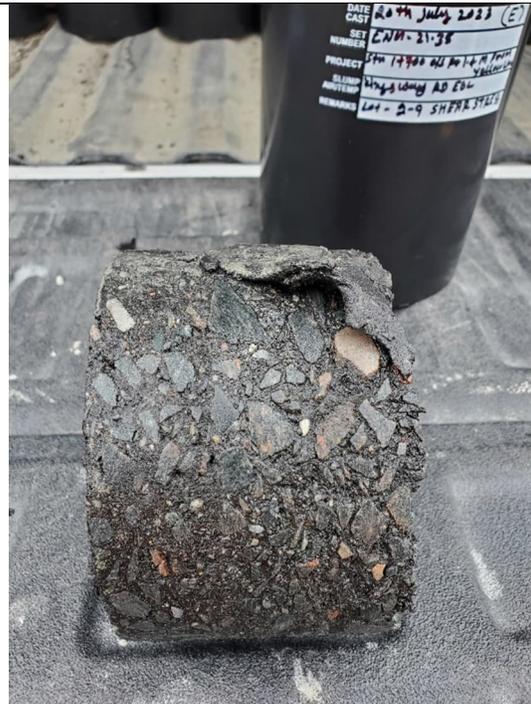
Photo 4: Core 10E with chunk of rubber stuck to the outside of the sample.

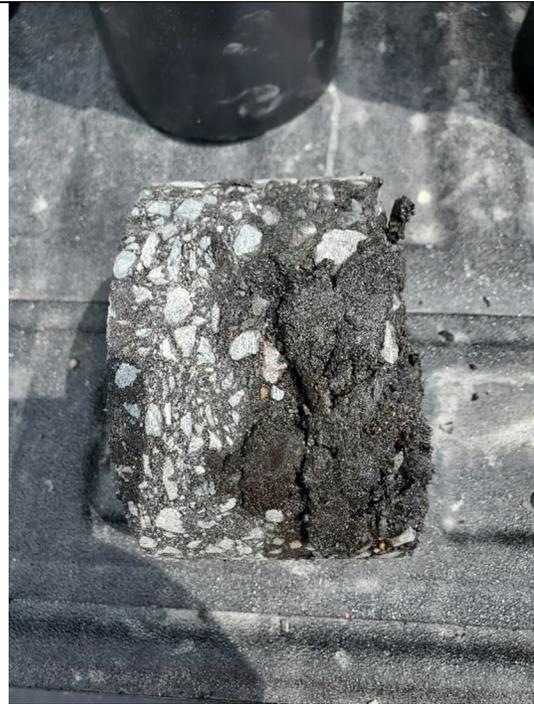
Photo 2: Core 17B (3-6, Q/C) with rubber stuck to outside of core sample.

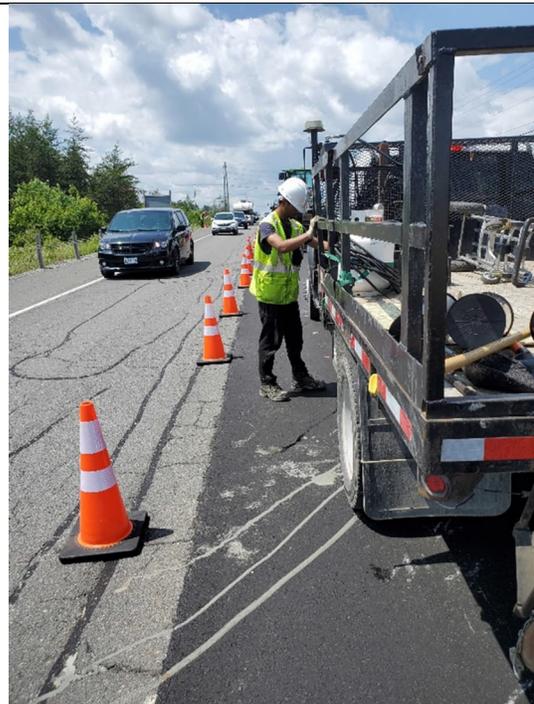
Photo 4: Coring Set 17 along Kingsway at STA 0+800, offset 3.2m from South yellow line.

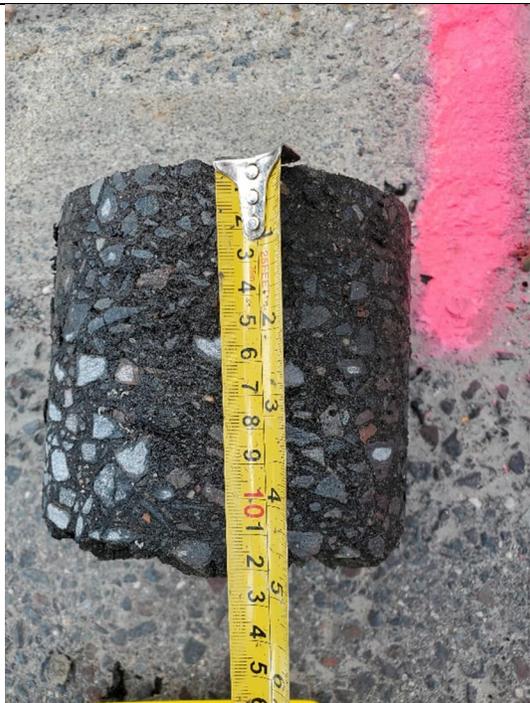
Photo 5: Additional Set 1, Core A1A.

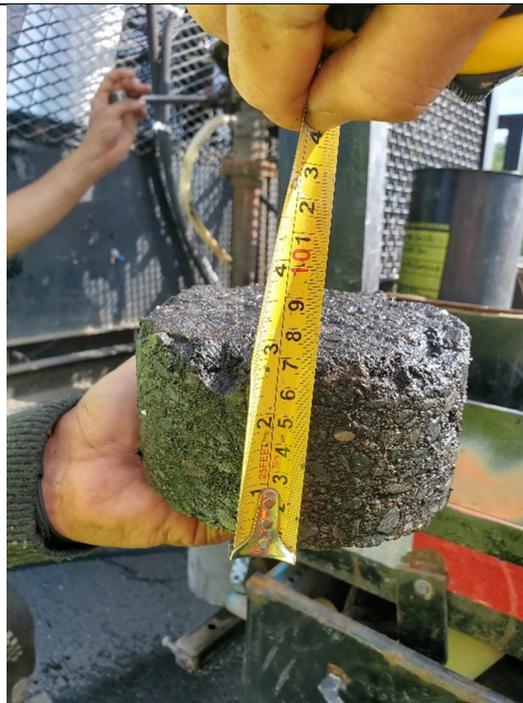
Photo 8: Additional Set 2, Core A2B.

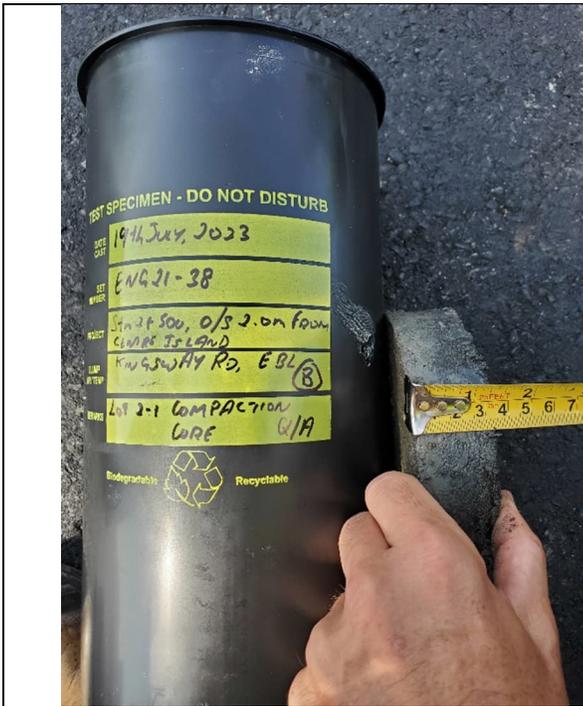
Photo 1: Core 2B next to its sample mould.

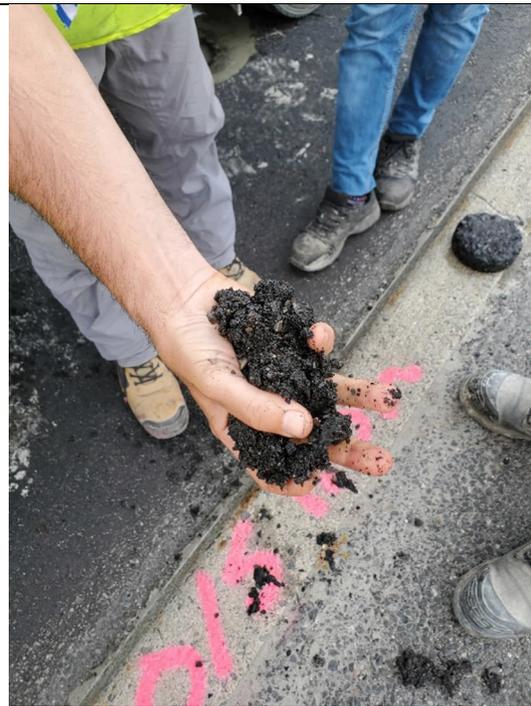
- Cores 5A, 5B, 5C, and 5D all had an undeterminable amount of wet, malleable asphalt/underlying material that fell off the core sample and into the hole when raising the drill bit from the ground. As shown in Photo 2 below.

Photo 2: Wet, malleable asphalt/underlying material from the 5<sup>th</sup> set of cores.

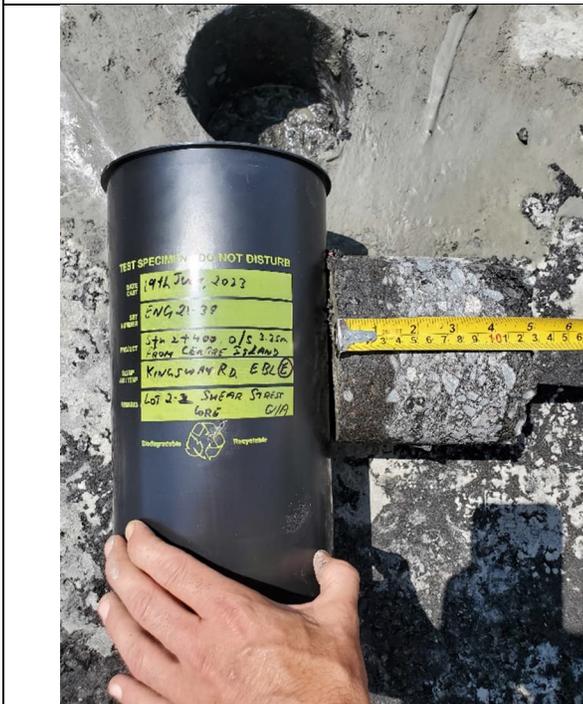
Photo 3: Core 3E next to its mould. Line between asphalt and underlying material is distinct.

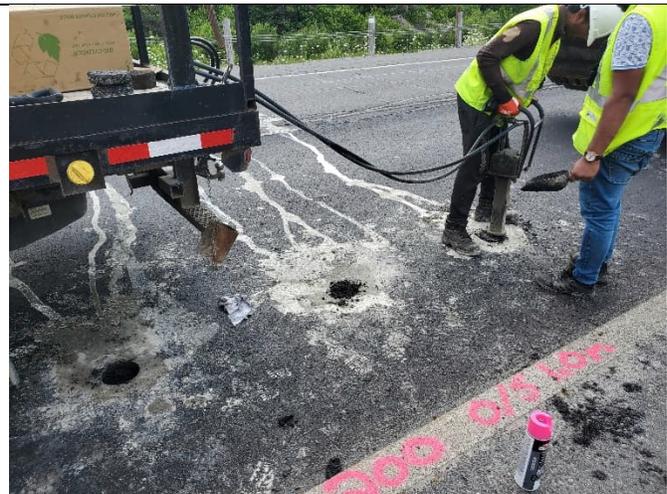
Photo 4: RSR packing the cold mix asphalt backfill.

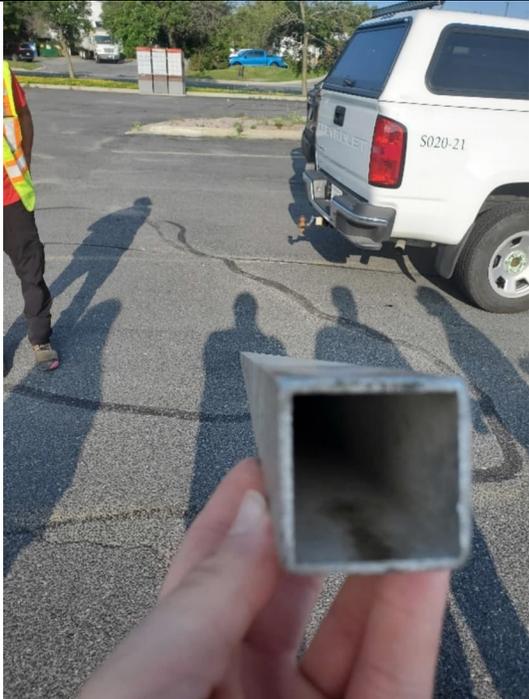
- WSP performed the asphalt level check until 9:45 when CGS shut the level check work down as it was slowing down the visual inspection.
  - A \$1 coin and \$0.25 coin were measured to be 3 mm when stacked on top of one another. These were used with a 25x25x3000mm straight edge (as shown in Photo 1) to determine whether the level was sufficient. If the gap was determined to be more than 3 mm, the gap was measured with a metric measuring tape.
  - The inspection and asphalt level check started at approximately STA 3+890 moving eastbound.
- The table below summarizes the asphalt level check work that was performed.

Photo 1: 3 m straight edge, used for level check.

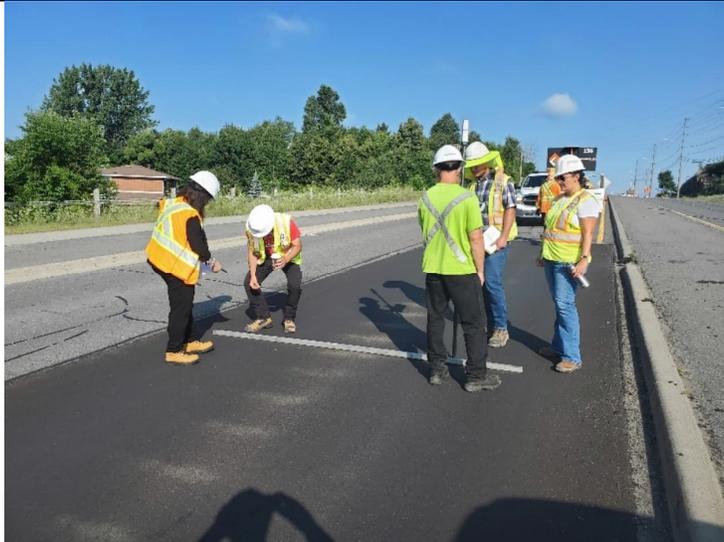
Photo 2: CGS and WSP checking asphalt level at Section 1.

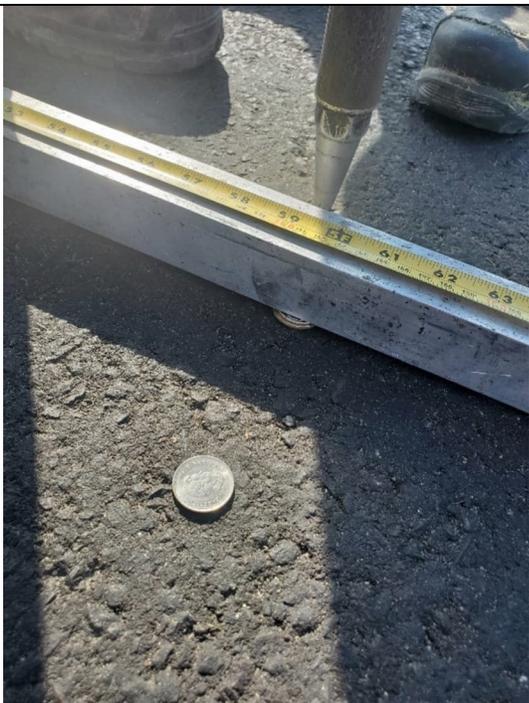
Photo 3: Survey Point 2, mid-lane 3 mm gap

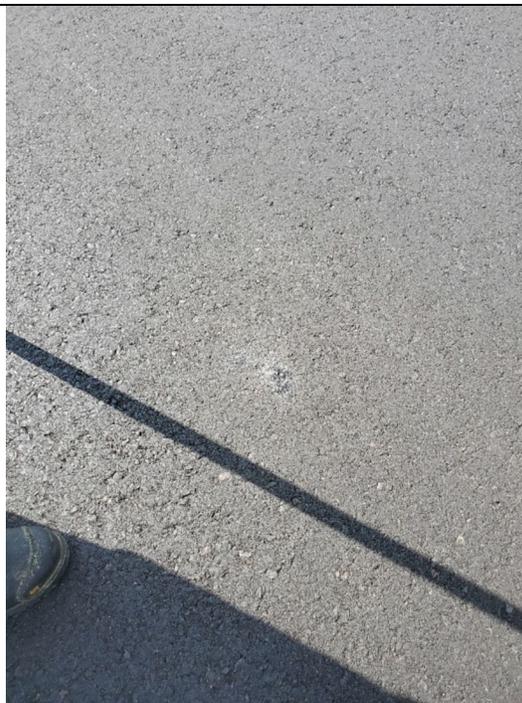
Photo 4: Moderate segregation at Section 8.

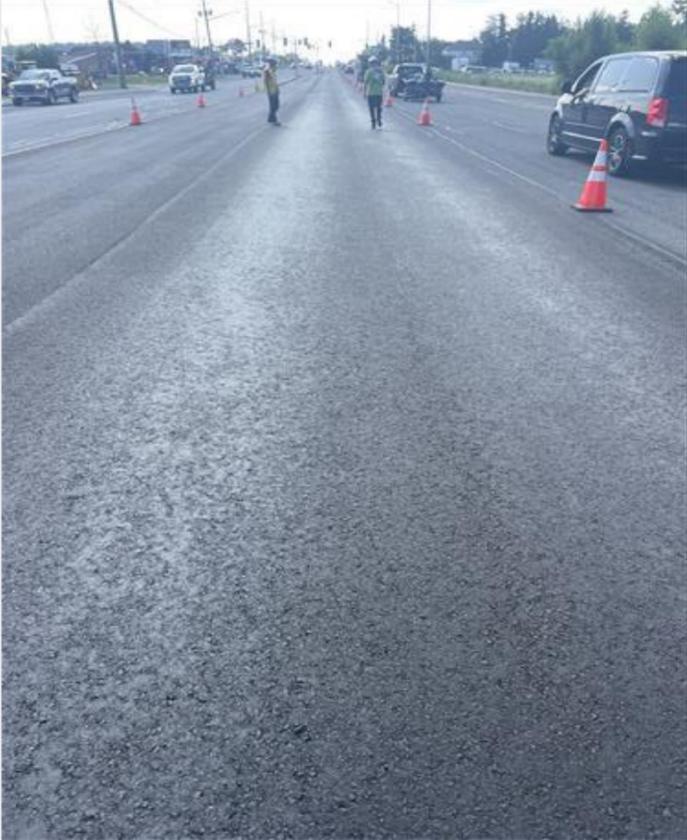
<b>PHOTOGRAPH</b>	<b>5</b>
		<b>STA 0+500 to STA 0+750</b>	
		Moderate Flushing/Bleeding

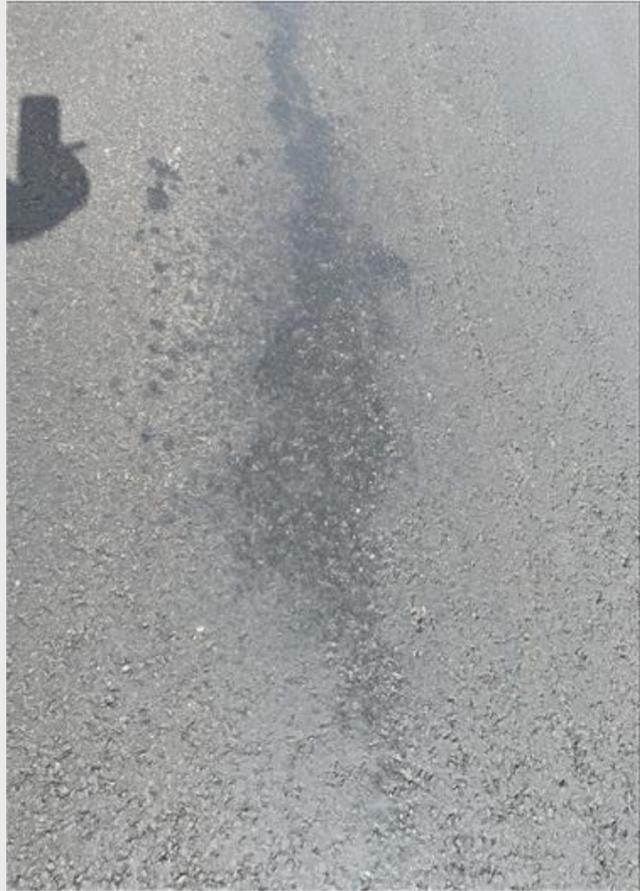
<b>PHOTOGRAPH</b>	<b>15</b>
		<b>STA 2+500 to STA 2+750</b>	
		Moderate Flushing/Bleeding Ravelling/Severe Segregation
